BEV Concerns

Will the Building Owner be deemed responsible
for BEV fire damage

Ian Childs
Principal, FIREASSESS.AU

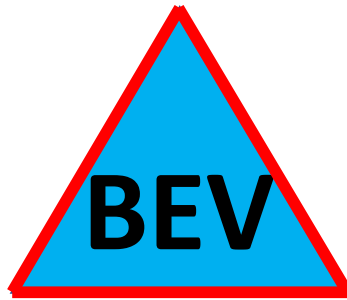
It was proposed that all buildings with BEV charging would have an ID plaque to warn first responders.
